## **Expanded Case Study: Sewer Pipe Defect Analysis Of El Paso Water Area 3**

### **1. Introduction**

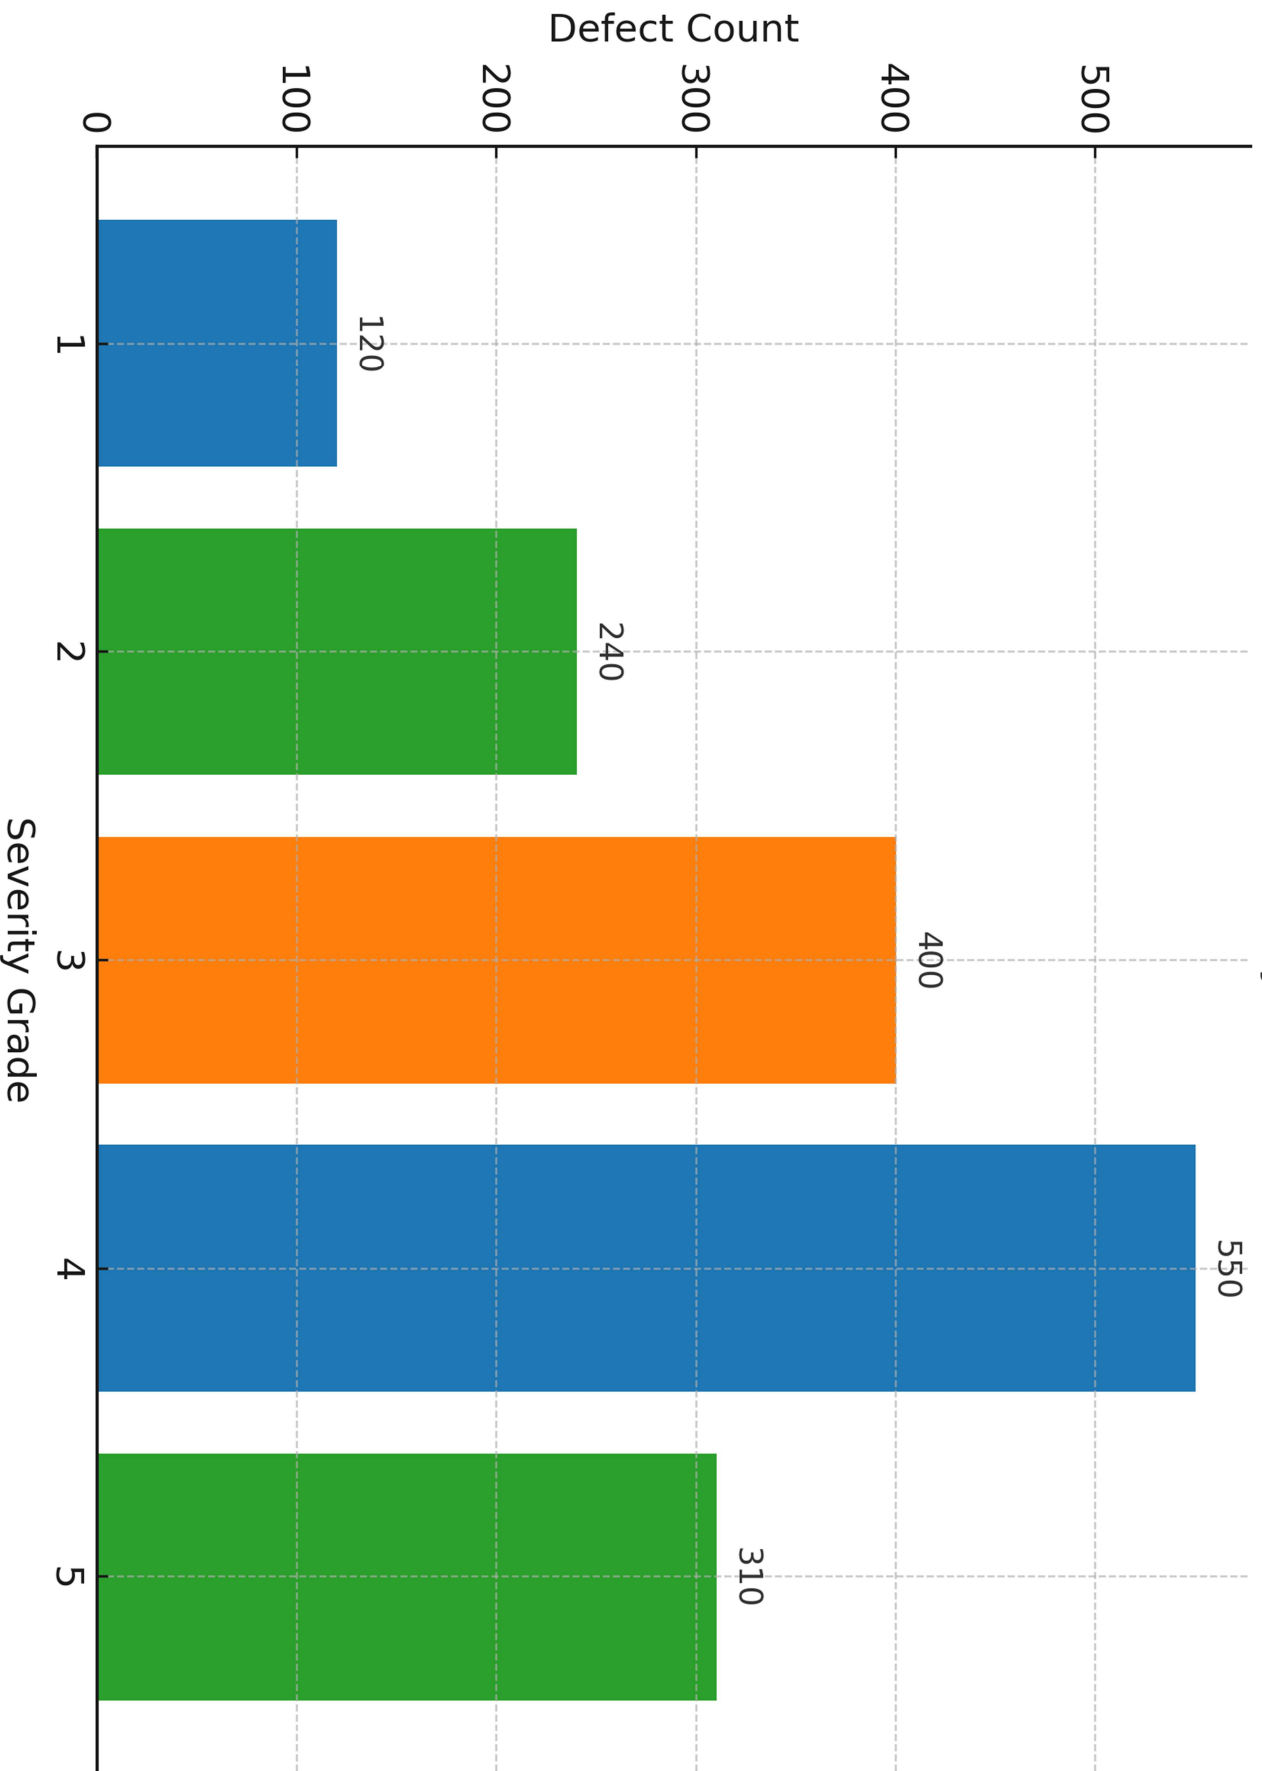
## Defect Severity Distribution

**a. Defect Severity Distribution:** This chart categorizes all recorded PACP defects by severity grade (1–5). It shows a pronounced concentration of Grades 4 and 5 among structural defects such as FL, FM, and FS, particularly in VCP pipes. In contrast, most O&M defects fall within Grades 1–3, though a portion of DNF entries reach Grade 4, signaling localized hydraulic concerns.

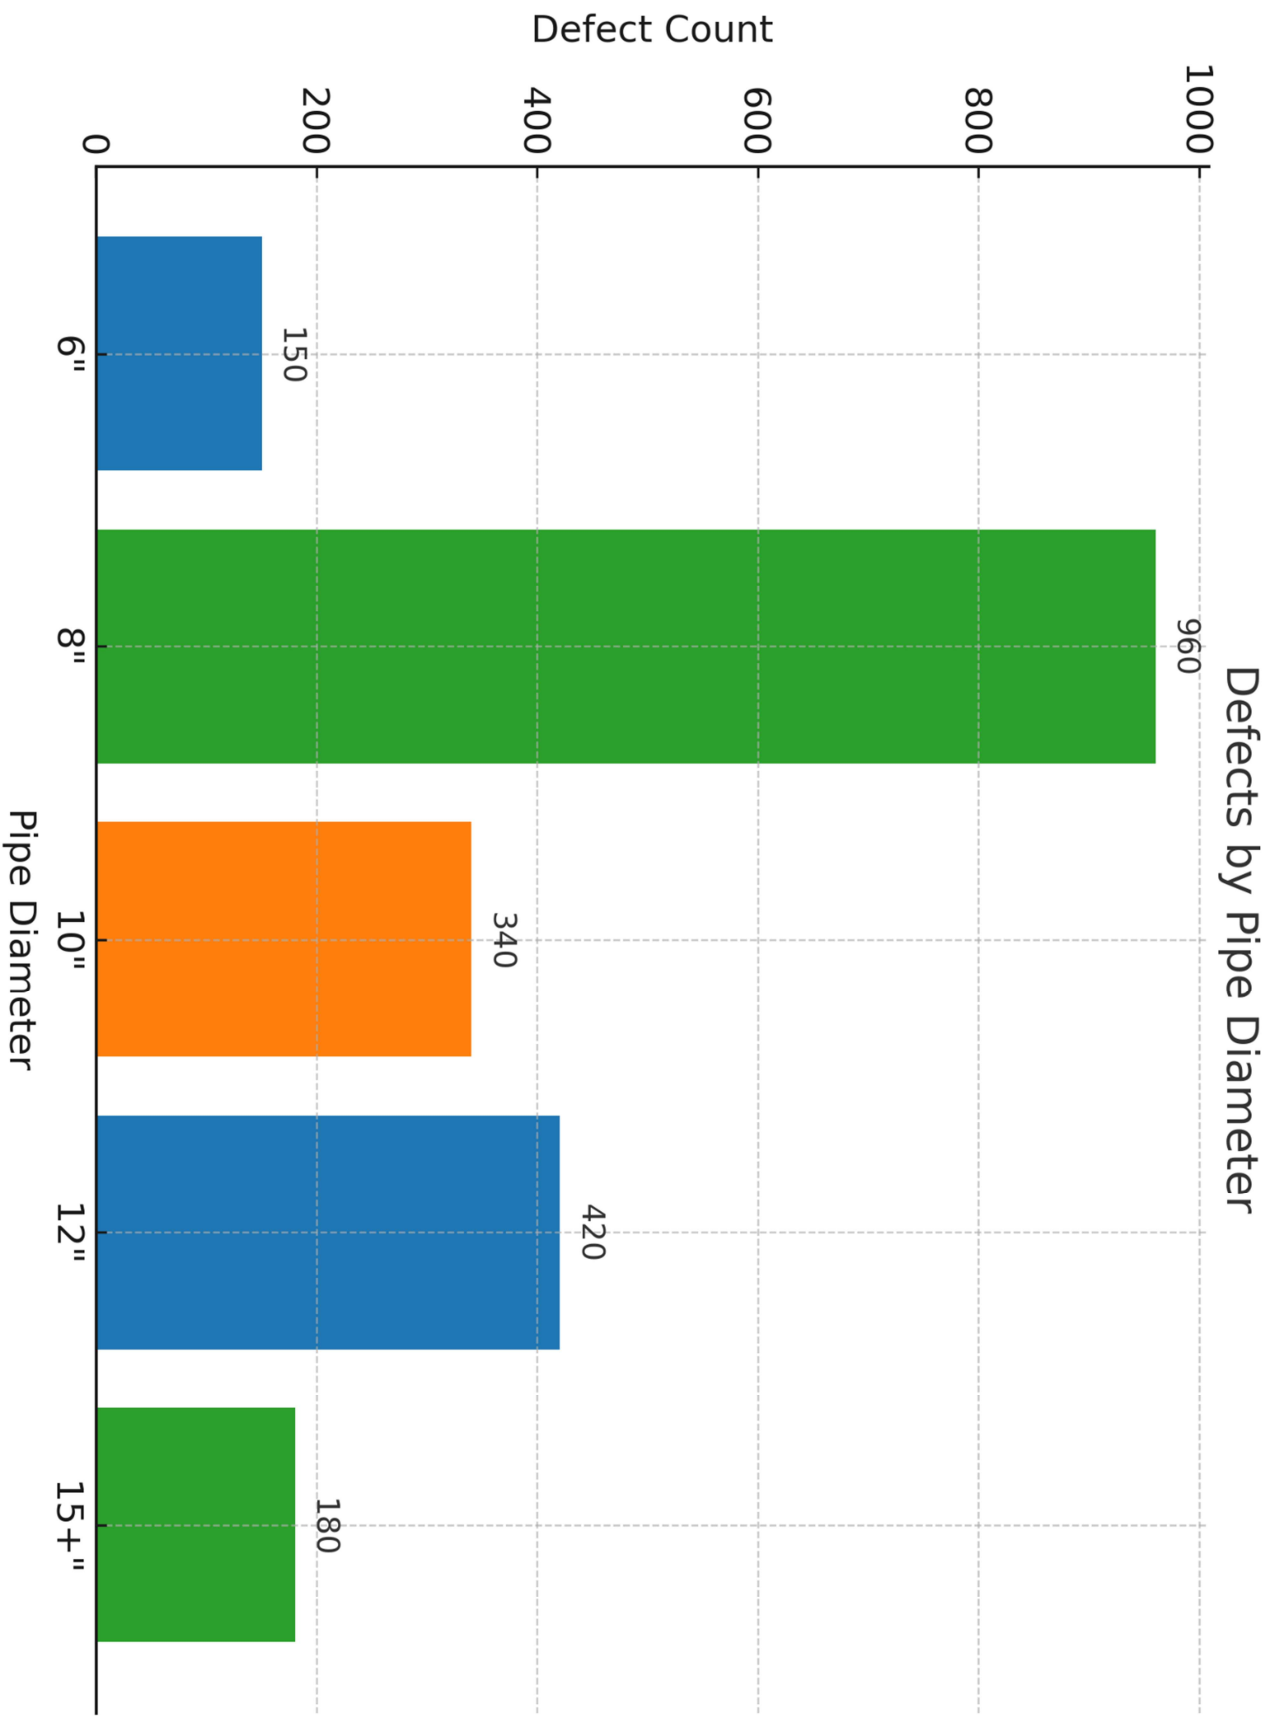
**d. Defects by Pipe Diameter:** This chart demonstrates the frequency of defects by pipe diameter. The highest concentration occurs in 8-inch pipes, a common diameter in many systems. The chart also reflects a secondary peak in 12-inch VCP pipes, indicating that larger-diameter legacy assets are also at elevated risk.
